Southern Marin Fire District

Fire Station 4 Seismic Retrofit and Interior Renovation

April 26, 2023 Board of Directors Meeting

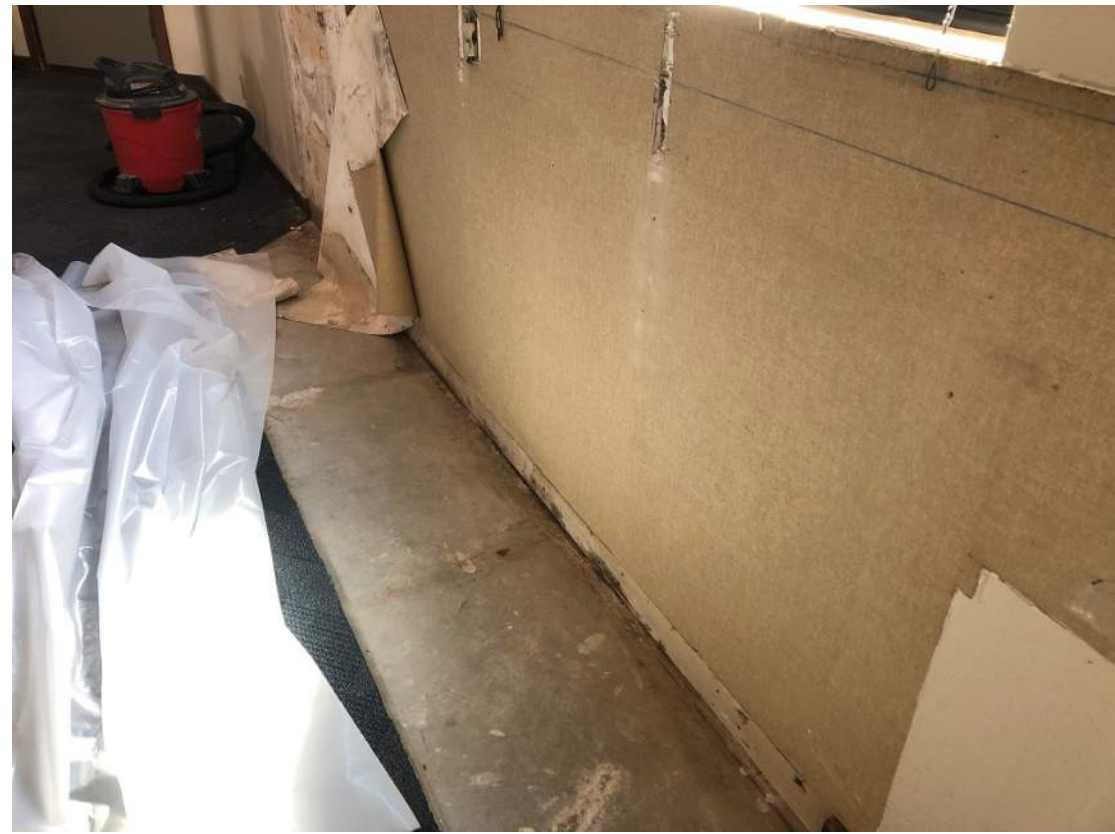
- Furniture and equipment is moved out of the Fire Prevention offices. The cabinets below the window along the southwest wall are disconnected from the wall and put in the dumpster.
- Contractor notes signs of mold at the base of the wall below the window. The result of the group's discussion is that the mold is the result of the water intrusion due to window leaks and dirt in contact with the base of the exterior wall.
- Contractor sends photo on 2/1 of the condition of the base of drywall below Fire Prevention windows

PHOTO 1 MOLD AT BASE OF WALL BELOW FIRE PREVENTION WINDOWS

- Contractor requests PCO (Potential Change Order) request to remove wall material, mitigate mold, and replace drywall along the southwest wall of Fire Prevention.

- SK-29 issued by BRW as confirmation for the contractor to proceed T&M (time and materials) for the removal, mold mitigation, and replacement of the wall in Fire Prevention.

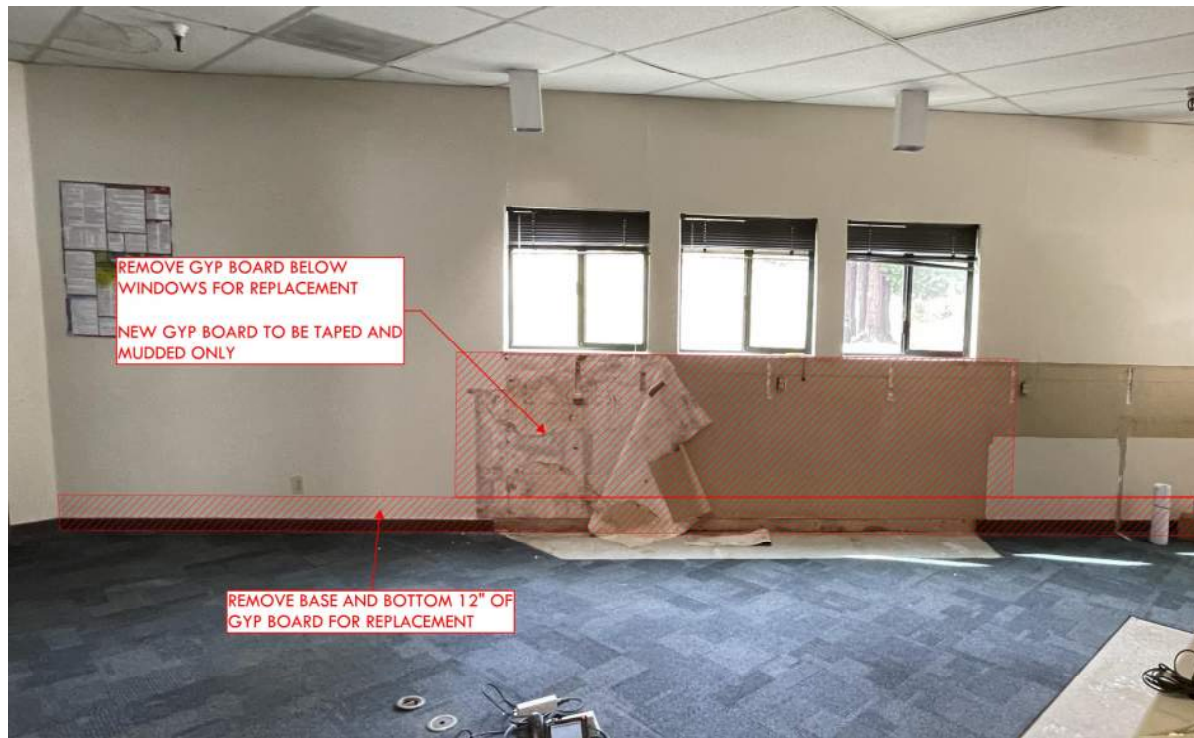
PHOTO 2: SK-2 BY BRW
DESCRIBING T&M SCOPE

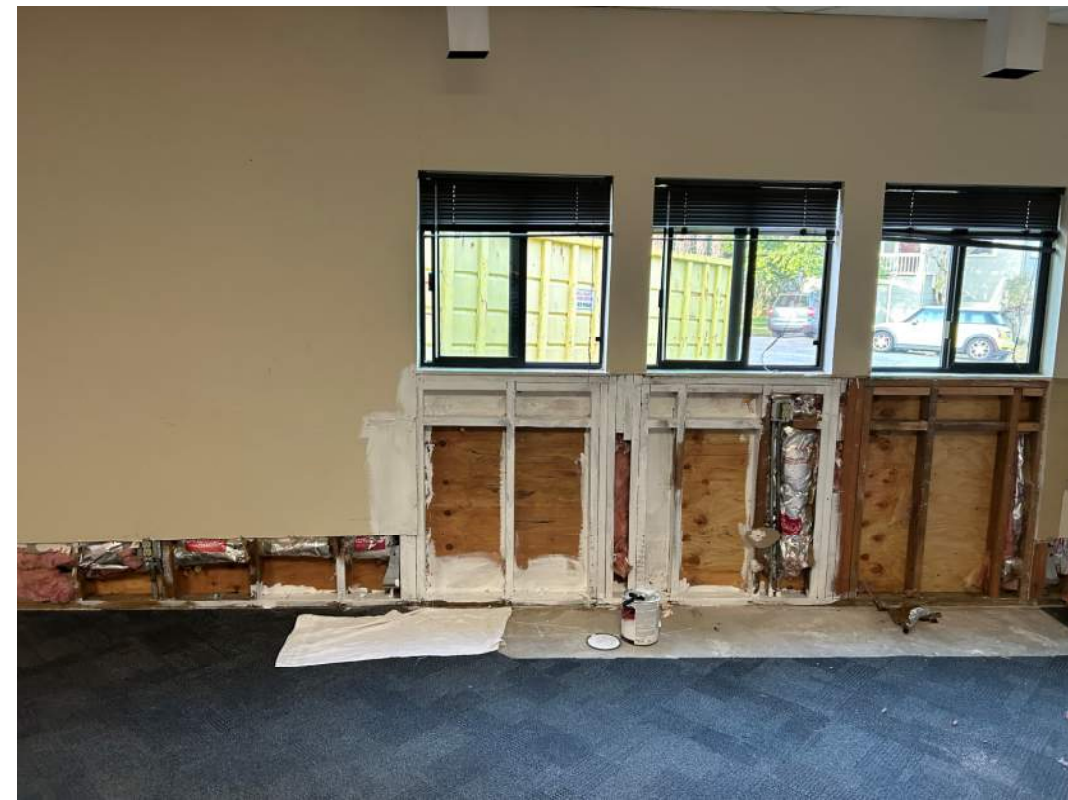
PHOTO 3: MOLD KILL PRIMER BEING APPLIED TO WALL

2/23: Contractor sends photo of progress of applying mold kill primer on all studs below the uncovered area.

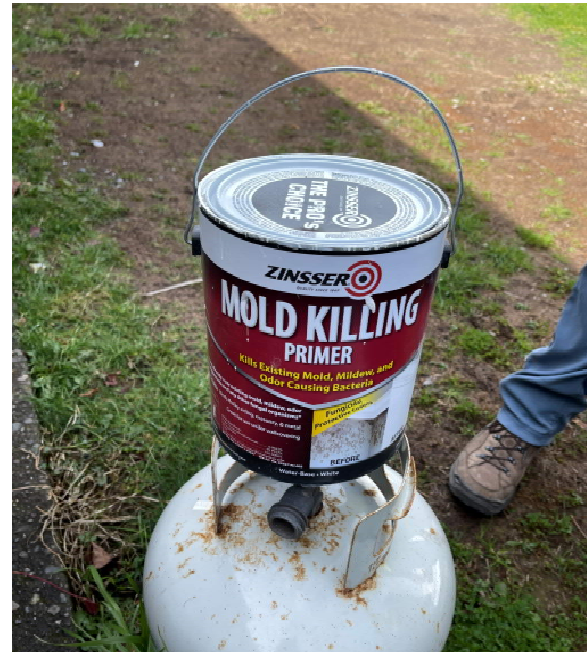
PHOTO 4: MOLD KILL PRIMER

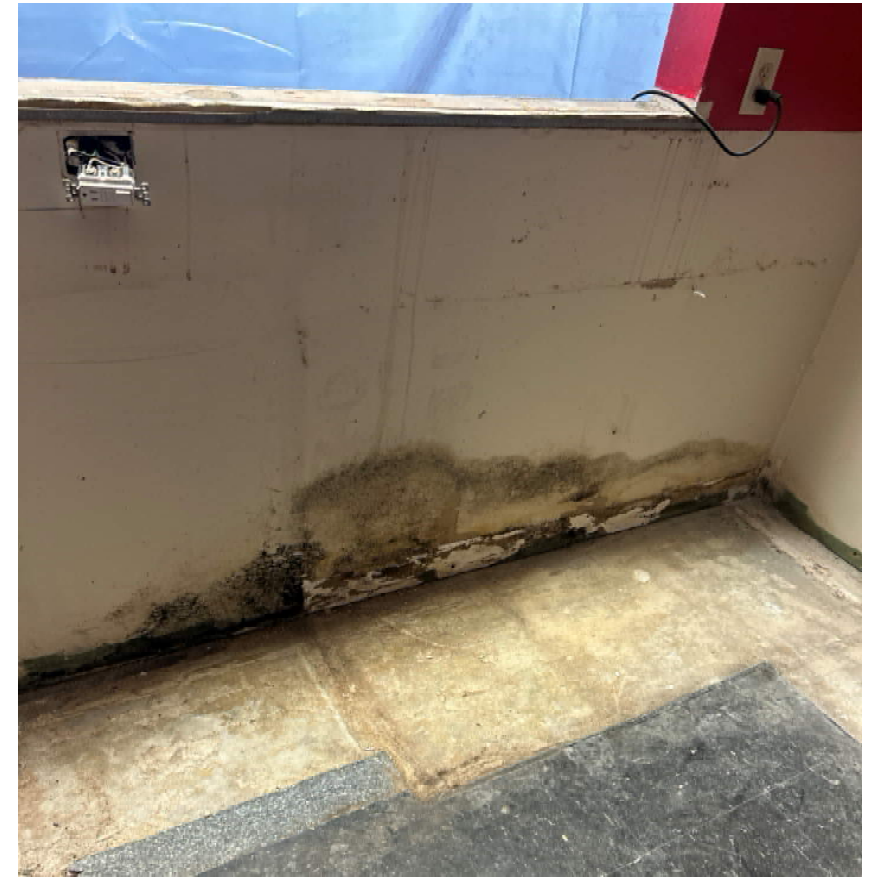
- Contractor sends photo of wall behind kitchen cabinets showing mold.

PHOTO 5: MOLD ON SURFACE OF WALL IN KITCHEN

- The crew has moved the living quarters furniture into the Fire Prevention office.
- The drywall on the inside face of the former kitchen cabinets has been removed and replaced.

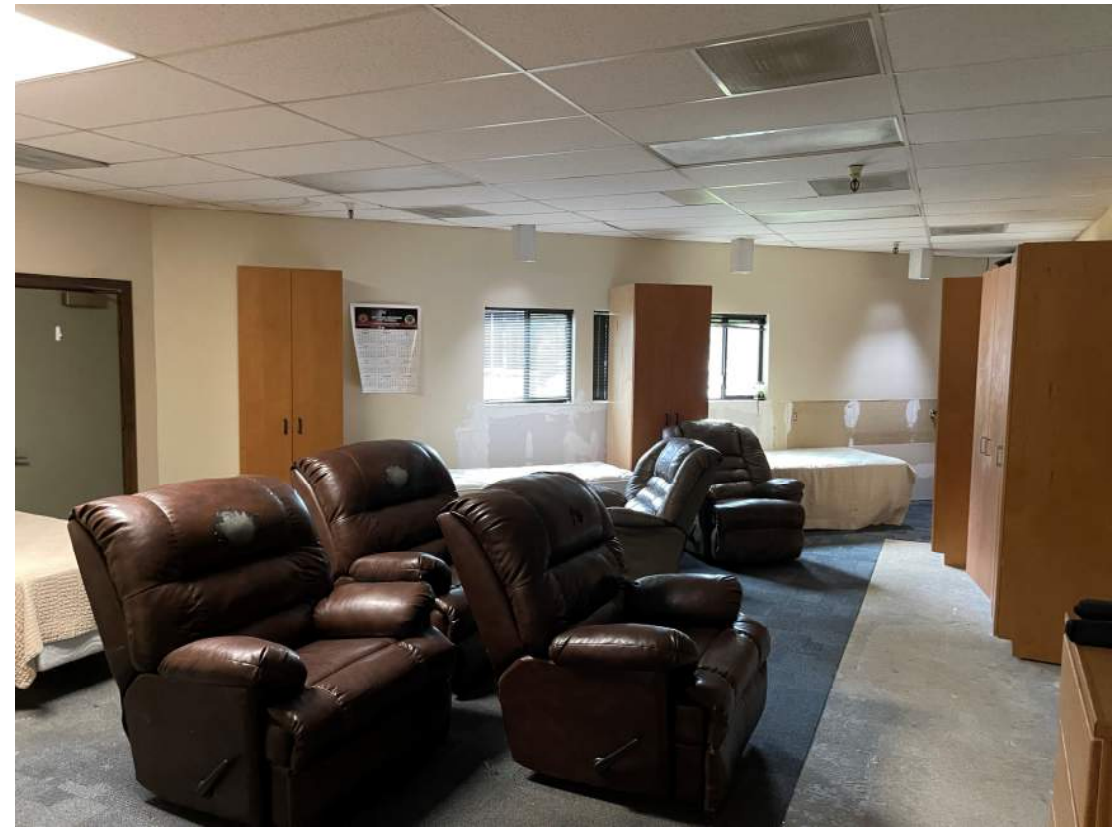
PHOTO 6: CREW QUARTERS IN FIRE PREVENTION

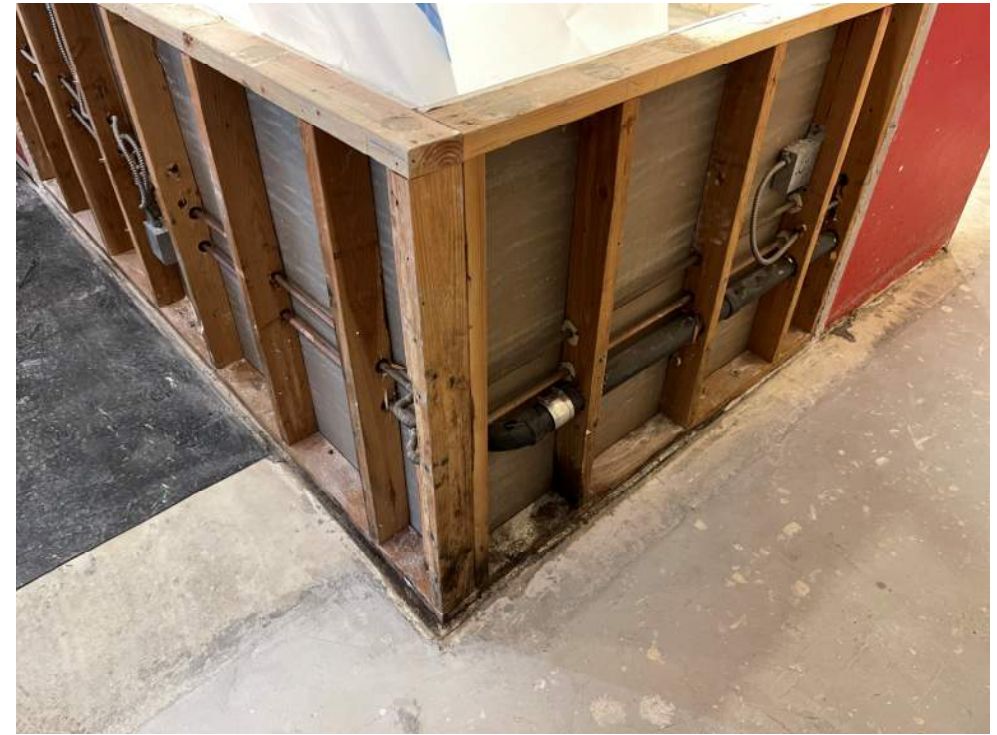
PHOTO 7: STUDS AT KITCHEN WALLS

- ARGOS Construction removes drywall below kitchen wall facing dining room and hallway
SEE PHOTO 7
- AMG 2-person crew on site to set up containment
